EVALUATION AND SELECTION REPORT CDRL A018

EAST LOCUST CREEK WATERSHED, RW-1
NEAR MILAN, MISSOURI
SULLIVAN COUNTY

January 2014

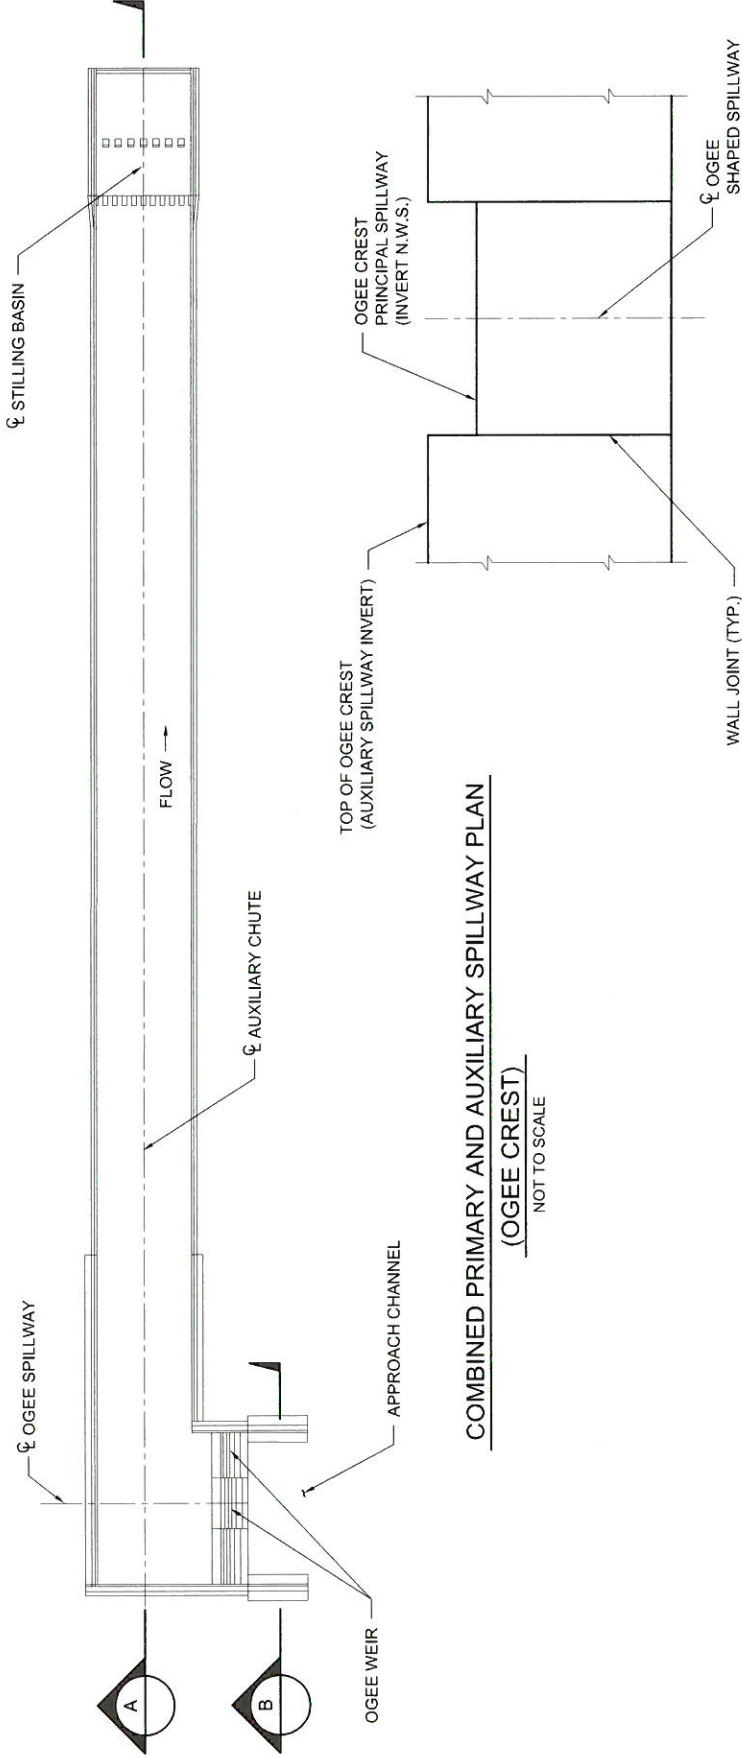
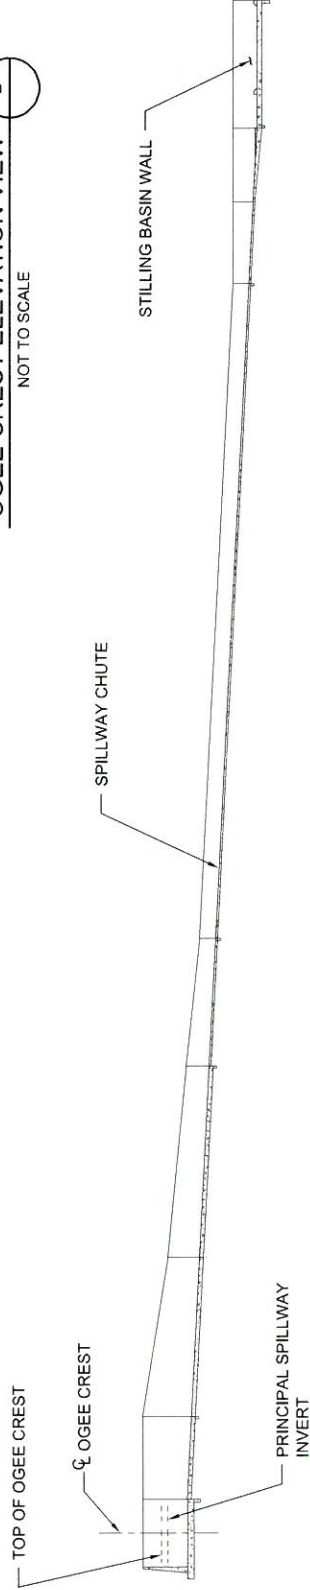
COMBINED PRIMARY AND AUXILIARY SPILLWAY (OGEE CREST) STRUCTURE ALTERNATIVE
NRCS EAST LOCUST CREEK RW-1

COMBINED PRIMARY AND AUXILIARY SPILLWAY PLAN
(OGEE CREST)
NOT TO SCALE

OGEE CREST ELEVATION VIEW (B)
NOT TO SCALE

COMBINED PRIMARY AND AUXILIARY SPILLWAY PROFILE (A)
(OGEE CREST)
NOT TO SCALE

- Conventional reinforced concrete ogee spillway on left abutment designed as a combination spillway for both principal and auxiliary flows.
- Conventional ogee or labyrinth spillway on the left abutment designed only for auxiliary spillway flows, in conjunction with a two-chambered combined outlet works/principal spillway tower.

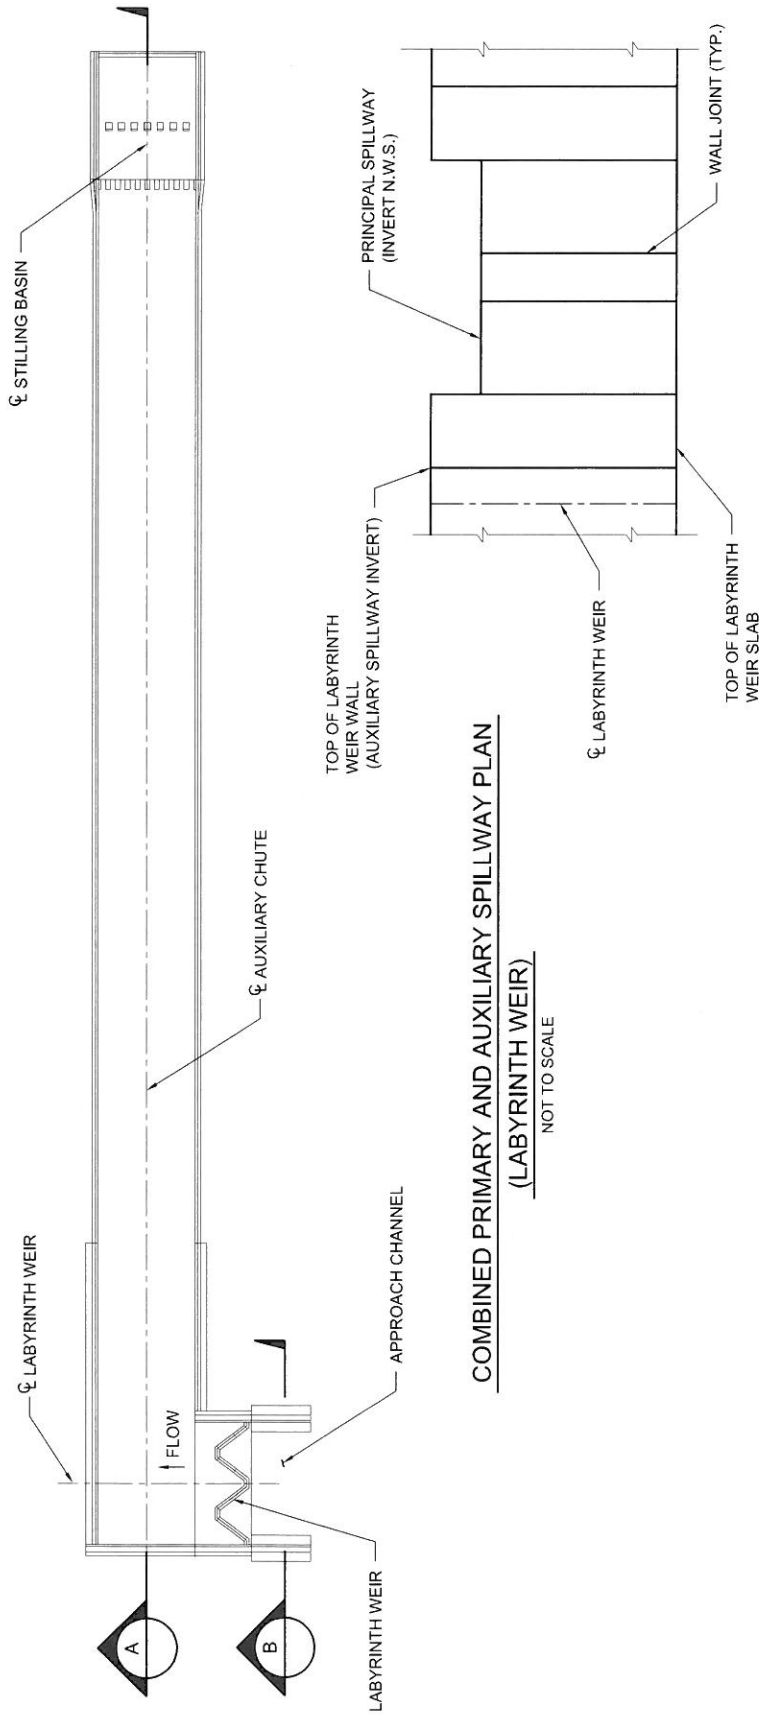
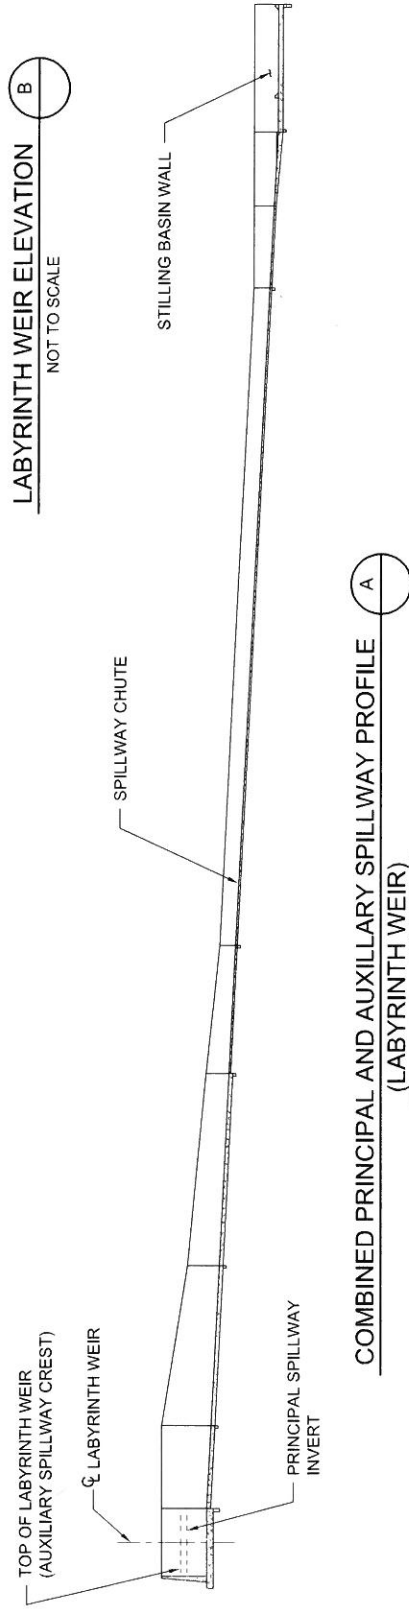
COMBINED PRINCIPAL AND AUXILIARY SPILLWAY (LABYRINTH WEIR) STRUCTURE ALTERNATIVE
NRCS EAST LOCUST CREEK RW-1

COMBINED PRIMARY AND AUXILIARY SPILLWAY PLAN
(LABYRINTH WEIR)
NOT TO SCALE

COMBINED PRINCIPAL AND AUXILIARY SPILLWAY PROFILE
(LABYRINTH WEIR)
NOT TO SCALE

LABYRINTH WEIR ELEVATION
NOT TO SCALE

Both alternatives require the same level of competency and skill by a concrete contractor. The advantage of the labyrinth over the ogee is that the labyrinth's design shape is such that it provides the peak design discharge as an ogee, but in a compressed overall spillway width. This reduces the amount of reinforced concrete required. Due to the smaller overall footprint, the labyrinth also requires less excavation and less backfill concrete to found the structure on bedrock. For these reasons, the labyrinth is the recommended spillway alternative.

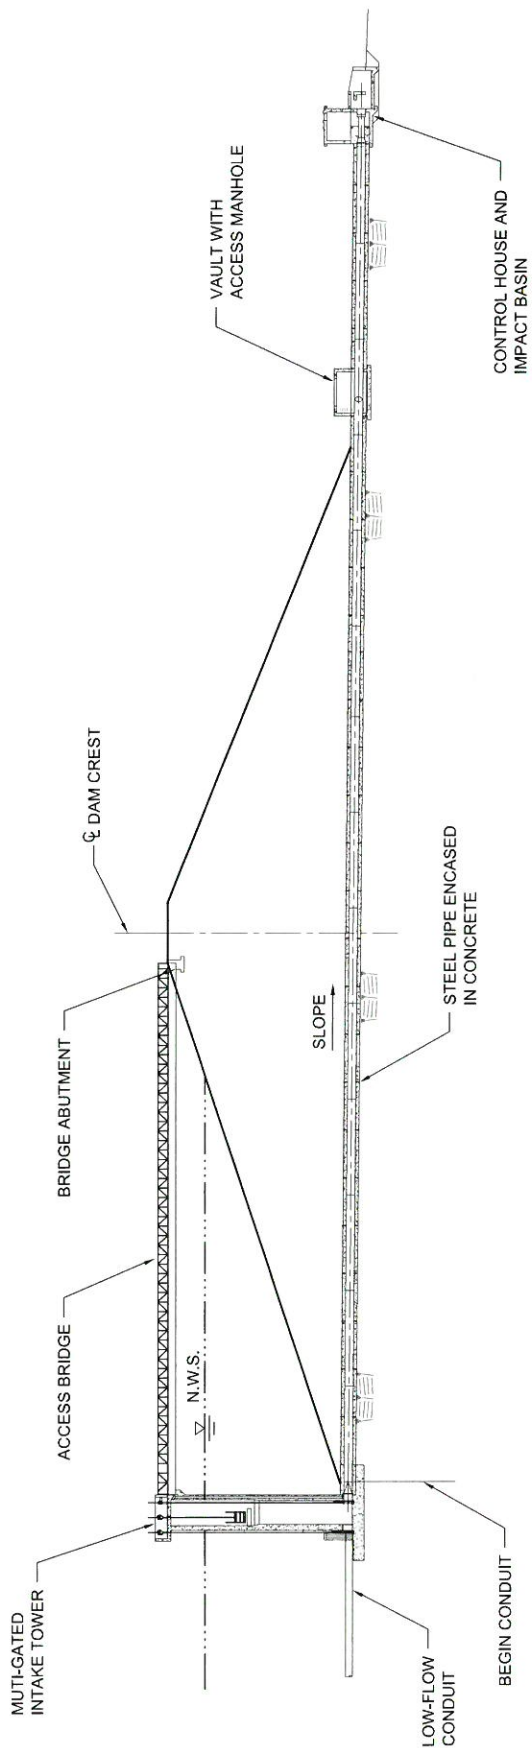
**MULTI-GATED OUTLET WORKS
STRUCTURE ALTERNATIVE**

MULTI-LEVEL OUTLET WORKS PROFILE

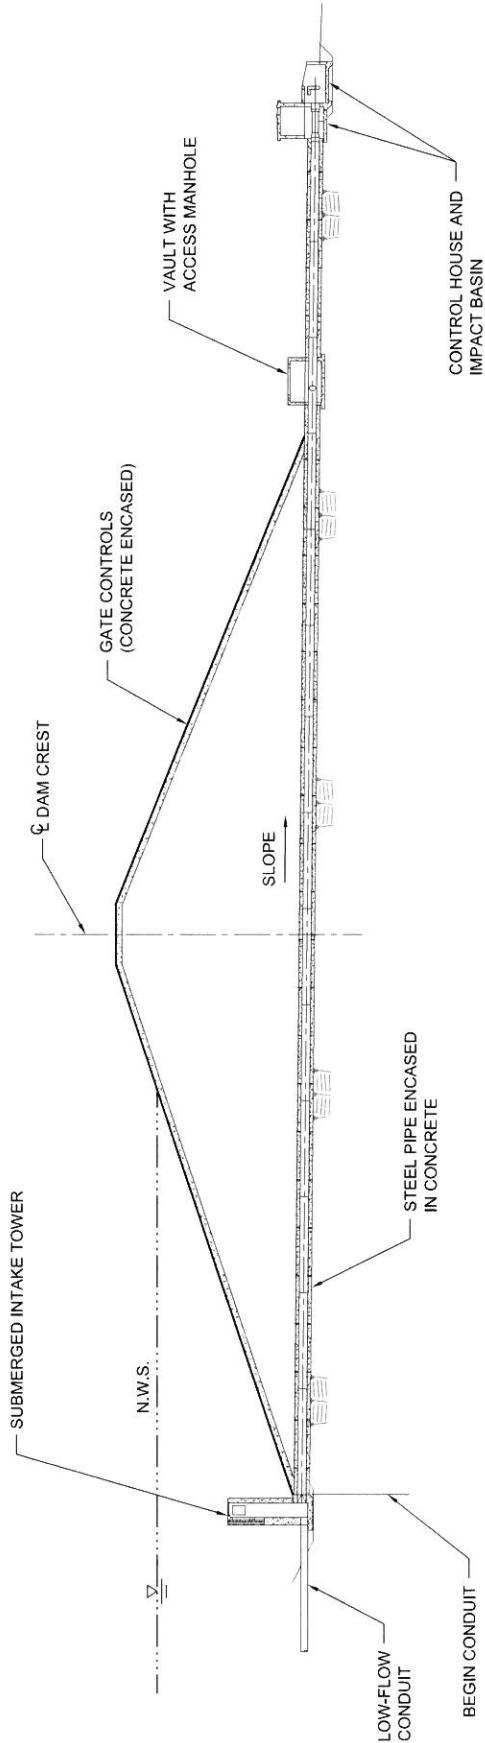
OUTLET WORKS WITH SUBMERGED INTAKE TOWER PROFILE

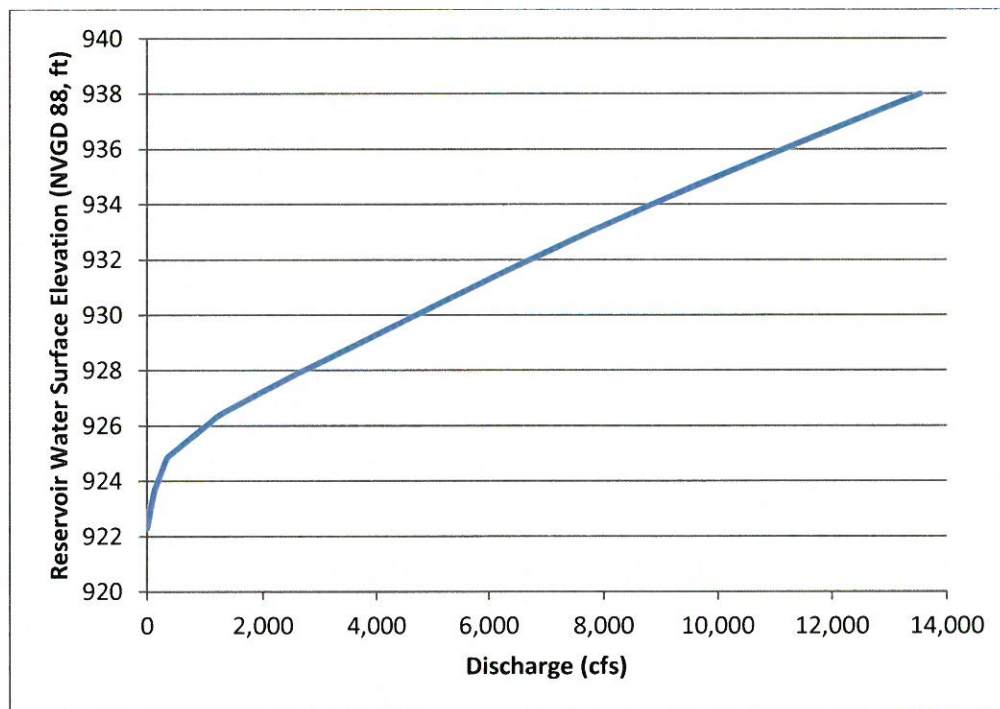
Figure 3.1. Labyrinth Weir Discharge Rating Curve

Elevation (ft)	Discharge (cfs)
Normal Pool and First Stage of Weir Crest Elev. 922.3	0
923.0	190
Second Stage of Weir Crest Elev. 924.8	341
926.0	1,030
928.0	2,719
930.0	4,716
932.0	6,719
934.0	8,844
936.0	11,167
Dam Crest Elev. 938.0	13,543
